Jointmaster®

Barkby Beach Promenade, Prestatyn

Problem: Repair of 144 movement joints in concrete promenade.

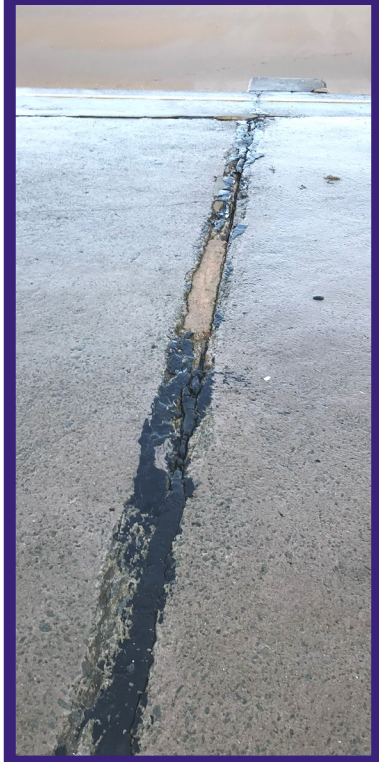
Failed joints required repair

Solution: Jointmaster repair 150mm, 200mm & 300mm wide & rebated by 25mm deep. The flexible material absorbs the movement in the joints without cracking or detaching from the surface.

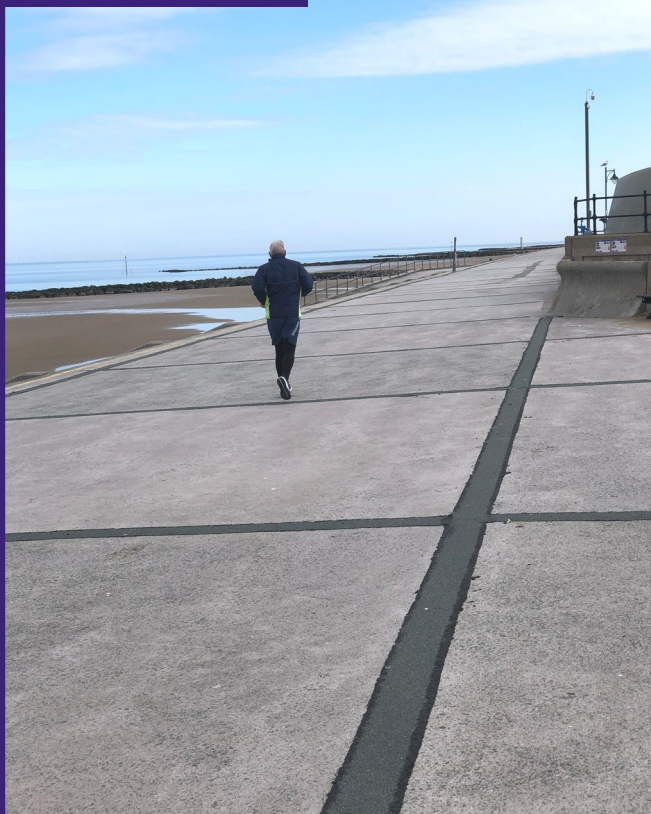
Joints repaired

- #### Facts & Figures:
- 1,890 Lin.m of 25mm deep repairs
 - Work completed in 10 days in February 2020
 - Carried out during daytime working
 - Works segregated and delineated to retain pedestrian and cycle access.
 - Joint planed out 25mm deep with varying widths and filled with flexible, long-lasting, Jointmaster crack repair.
