# Case Study

## Jointmaster Fill & Overband

### Eye Road, Peterborough

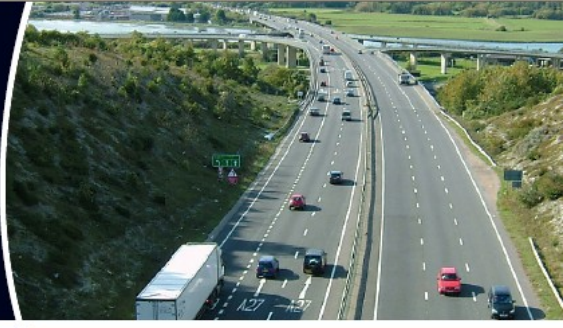
**Problem:** Centre joint failure & transverse cracking

**Solution:** Jointmaster Fill and Overband material was applied to fill and seal the joints and cracks. A band of 200mm wide was applied to the surface to cover over any fretting and open joints.

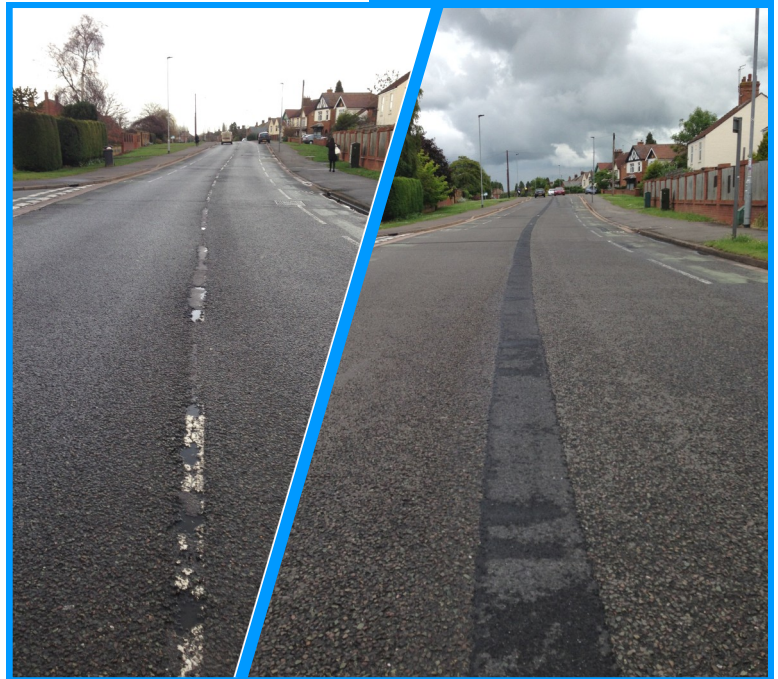
Longitudinal seam joint

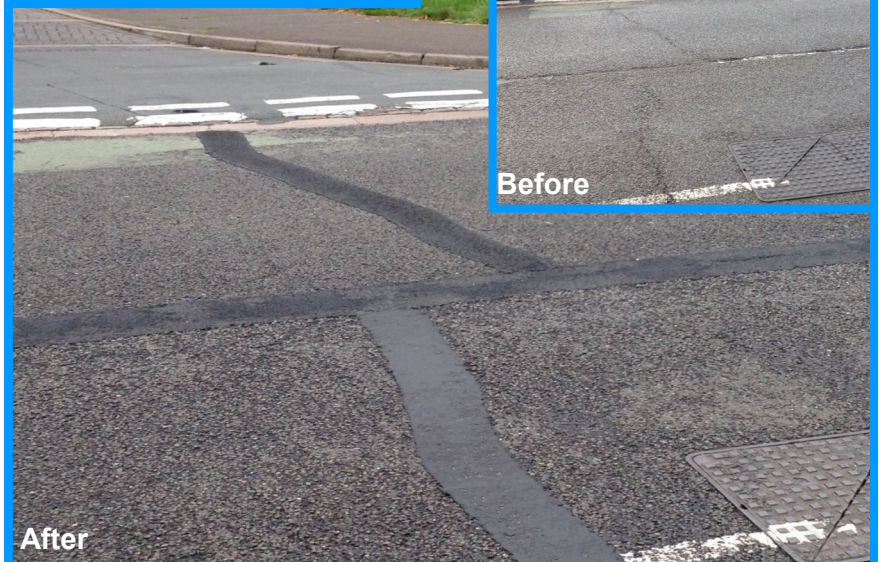
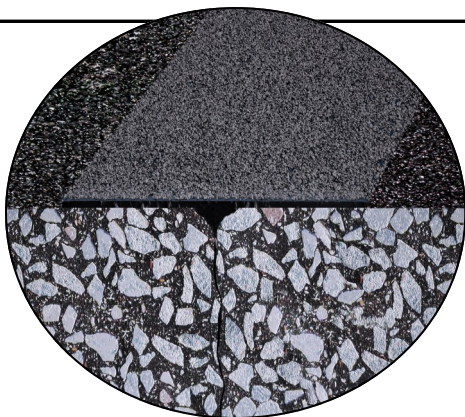
Transverse & Longitudinal repairs
